Surface Deformations and Rupture Processes Associated with the 2017 M_w 5.4 Pohang, Korea, Earthquake

Abstract In November 2017, an M_w 5.4 earthquake with a shallow (~ 4 km) hypocenter occurred in the Pohang area, one of the most developing industrial cities in South Korea. This shock resulted in the costliest earthquake damages in modern Korean history. Immediately after the event, it was not easy to recognize the source fault due to the lack of clear coseismic surface ruptures but also the absence of previously mapped active faults around the epicenter. Based on satellite- and unmanned aerial vehicle (UAV)-derived images, with ground resolution higher than 0.5 m, and field observations, we investigate surface deformation such as sand blows and ground failures associated with the Pohang earthquake as well as bedrock fault exposures in the epicentral area. To better constrain the source fault and deformation mechanism, we combine both moment tensors with aftershock relocations and surface displacements estimated by Interferometric Synthetic Aperture Radar (InSAR). Our results indicate that (1) various types and distributions of secondary ground deformation were controlled by blin

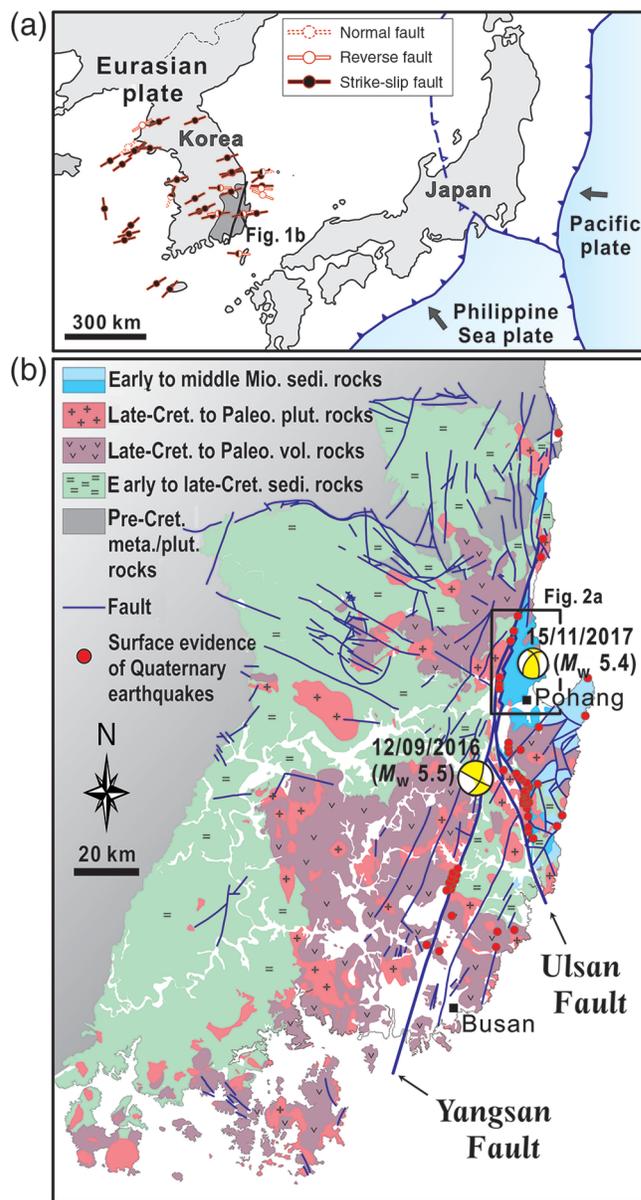
Figure 1. (a) Simplified tectonic map of study region. Bars indicate the maximum horizontal stress orientations with fault types determined by focal mechanisms from 40 earthquakes greater than or equal to M_w 3 from 1996 to 2014 (from the Saint Louis University Earthquake Center). (b) Geological map of the Gyeongsang basin, modified from the Korea Institute for Geosciences and Mineral Resources Geological Map. Circles indicate previously identified Quaternary surface faulting, primarily along the Yangsan–Ulsan fault system.

The southeastern part of the Korean Peninsula is located on the Eurasian plate and tectonically controlled by subduction of the adjacent Pacific and Philippine Sea plates (Fig. 1a), and collision of the Indian plate with Eurasia. Cenozoic tectonic deformation is primarily accommodated along two major structures, the Yangsan and Ulsan faults (Fig. 1b). Crustal deformation is also distributed across the eastern block of the Yangsan–Ulsan fault system (YUFS). Post-Oligocene southeastward directed rifting across this block resulted in northeast–southwest-trending extensional faults, and a number of structural basins were formed on the Cretaceous volcano-sedimentary succession (Yoon *et al.*, 2014; Son *et al.*, 2015). The Pohang area is also composed of middle Miocene sedimentary rocks with less than ~900 m of strata thickness on land (Song *et al.*, 2015). Since the Pliocene, the stress field has transitioned from extension to compression resulting in reactivation of pre-existing normal faults with reverse sense of motion (Kim and Park, 2006; Choi *et al.*, 2015).

estimated by focal mechanisms from 40 earthquakes greater than or equal to M_w 3 from 1996 to 2014 (data from Saint Louis University Earthquake Center; Fig. 1a).

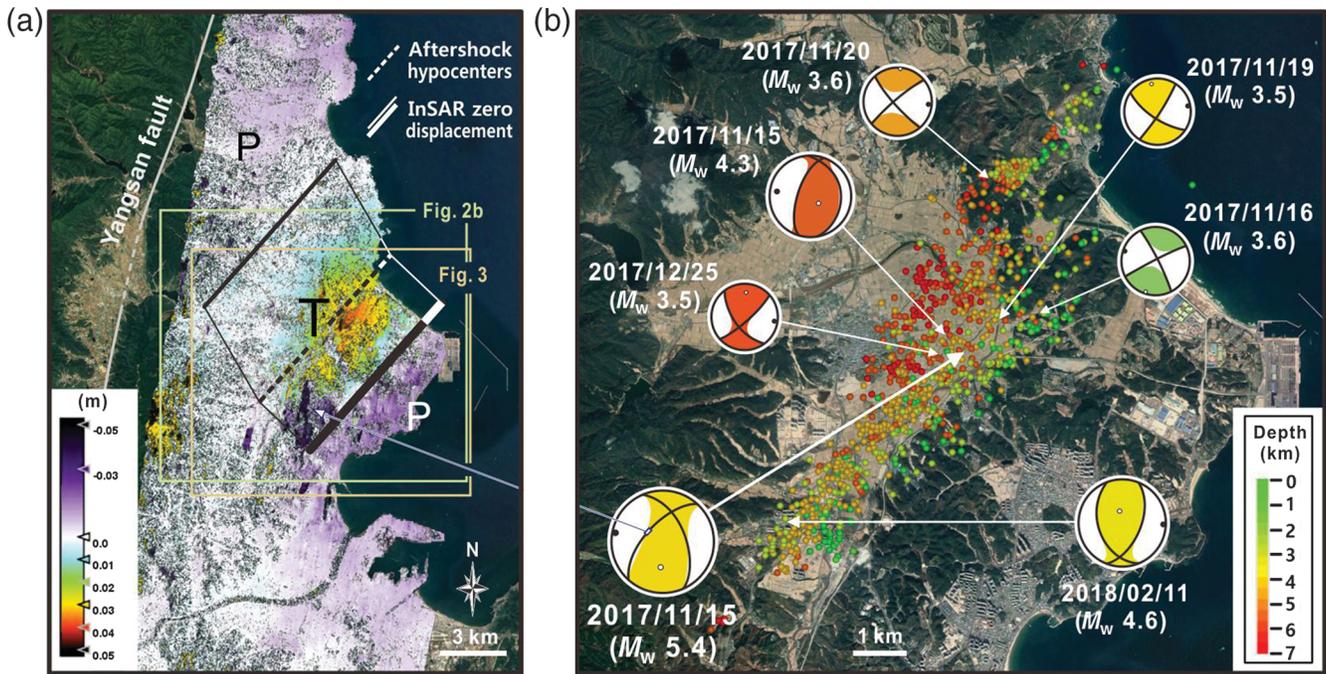
Figure 2. (a) Line-of-sight displacement map from Sentinel-1 Interferometric Synthetic Aperture Radar (InSAR) acquired on 4 and 16 November 2017. Positive values indicate uplift/easting of the ground while negative values are subsidence/westing. Distribution of ground displacements is consistent with a thrust focal mechanism for the mainshock. (b) Seismicity map of the 2017 Pohang earthquake sequence for the three months after the mainshock. Focal mechanisms are shown for the mainshock and major aftershocks greater than M_w 3.

During the 100 days following the Pohang earthquake, more than 1300 seismic events were recorded on five temporary seismic stations (Fig. 2b), which were deployed around the epicenter and equipped with Q330HRS data loggers and Güralp CMG-40T sensors. About 1149 aftershocks were analyzed using cross correlation of *P* and *S* waveforms to determine the rupture plane. The results indicate that the main rupture occurred along a plane oriented $N31^\circ E$ – $N50^\circ E$ and dipping 60° – 65° northwest (Cho, 2018). The direction of maximum horizontal stress by inversion of stress for the moment solutions is $N80^\circ W$ (Cho, 2018). That is slightly different from the known east-northeast–west-southwest maximum compression direction in the region. The seismically estimated fault plane correlates with the fault-plane solution determined from moment tensor inversion. Aftershock focal depths range from 2 to 7 km, and their along-fault distribution implies that the length of the main rupture was about 6 km. The two most significant ($M_w > 3$) aftershocks were triggered on neighboring fault segments: (1) the 20 November 2017 M_w 3.6 event on subvertical fault to the north and (2) the 11 February 2018 M_w 4.6 event on anti-thetically dipping fault to the southeast (Fig. 2b).

Figure 2a is the displacement map associated with the Pohang earthquake in the LoS of the radar. About 4 cm uplift/easting displacement (red area) was estimated near the epicenter. A compressional quadrant (CQ shown as T in Fig. 2a) can be defined as a region with more than 2 cm displacement (green to red), which is roughly an oblique ellipse shape with a major axis of 6 km in the northeast–southwest direction, a minor axis of 4 km in the northwest–southeast direction, and an area of 16 km^2 (excluding ocean). Negative LoS displacement of up to -2 cm (purple) occurred in the southeastern part, which is thought to be a part of a dilatational quadrant (DQ shown as P in Fig. 2a). A white zone implying zero displacement lies between the CQ and

DQ with a direction of northeast–southwest. This zone corresponds with the surface projection of the earthquake rupture plane as determined by analysis of the seismic data. A slight DQ also appears in the northwest region of the CQ bordering with zero displacement (white), which completes a surface representation of a reverse fault. A linear slip inversion using the InSAR data suggests that an average coseismic slip of 15 cm occurred during the main rupture with the majority of slip concentrated northeast of the hypocenter rather than in the southwestern part (Song and Lee, 2018).

Two aftershocks occurred at both lateral tips of the main rupture (Fig. 2b). To the north, an aftershock occurred on a subvertical fault showing a left-stepping geometry subparallel to the main rupture. The distance between the two faults is about 2 km. To the southwest, an aftershock ruptured a fault with an opposite dip to the main rupture. The fault system associated with the Pohang earthquake sequence, therefore,

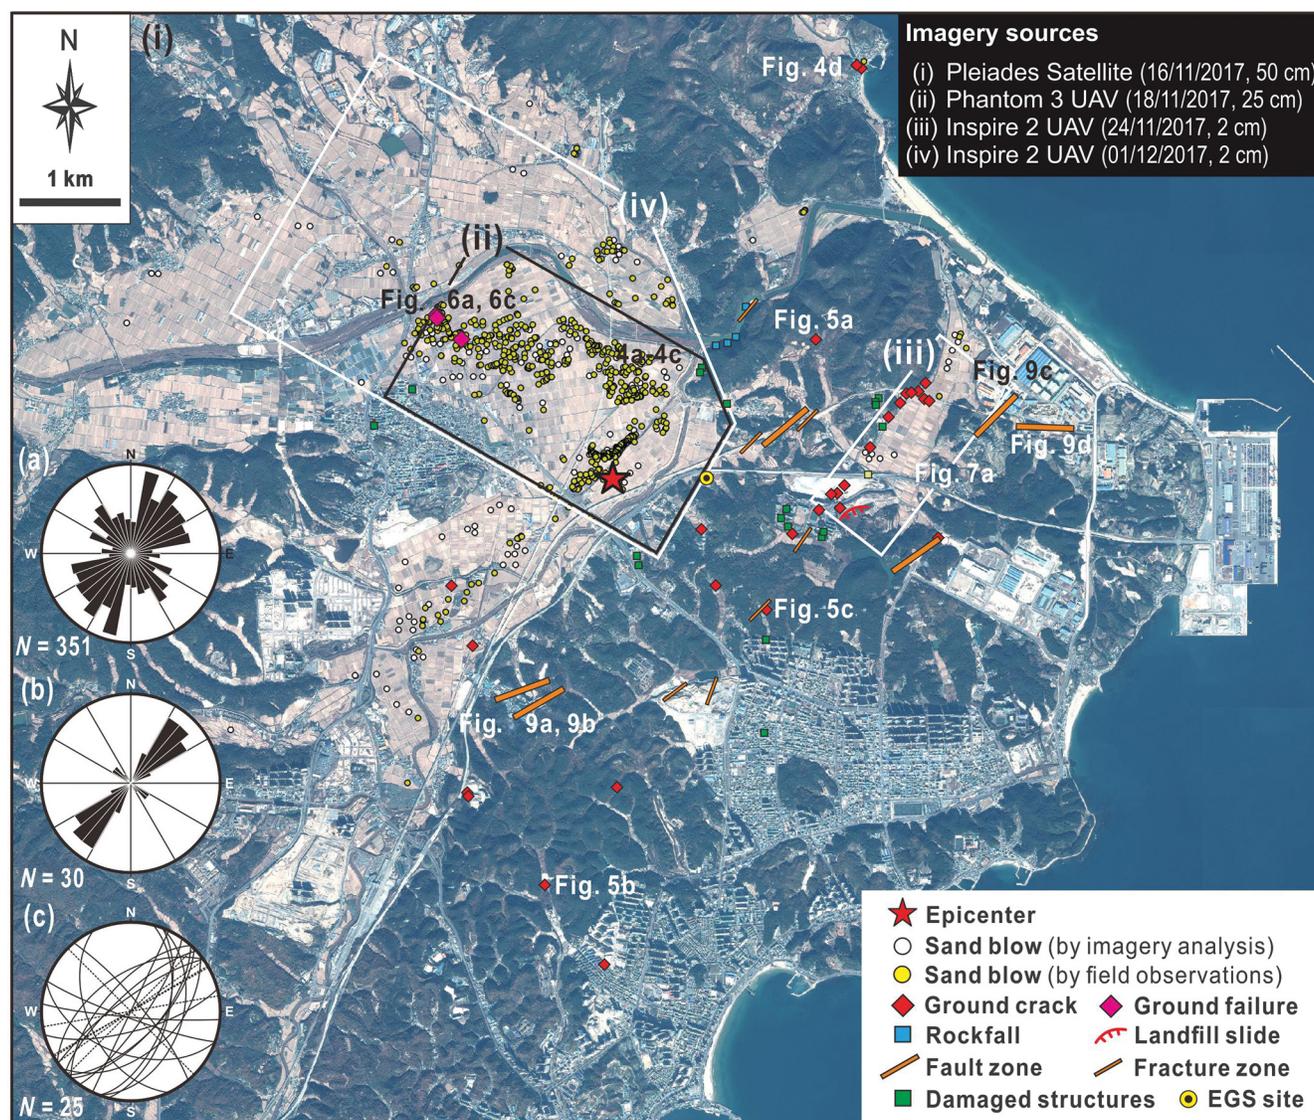
Figure 3. Map of surface deformations associated with the 2017 Pohang earthquake sequence. Deformational features and secondary effects of the earthquake include sand blows, ground cracks, rice paddy failures, rockfalls, and landfill slides. (Inset a) Orientations of sand blows (adapted from Gihm *et al.*, 2018) and (inset b) ground cracks are mostly parallel to (inset c) the direction of the main rupture as well as bedrock faults and fractures.

blows, ground cracks, deformed rice paddies, landfill slides, and rockfalls (Fig. 3). Here, we provide an overview of our observations for each type of ground deformation.

The majority of the sand blows are concentrated on the northwestern side of the rupture and within a 3 km radius of the epicenter (Fig. 3). This asymmetric distribution may be due to the existence of unconsolidated sediments on the northwestern side of the epicenter, which are susceptible to liquefaction and ground-motion amplification. We infer that the distribution of sand blows is a function of the location of coseismic ground cracks in areas of liquefiable sediments.

Pre-existing faults are exposed in Miocene mudstone bedrock in the foothills east of the epicenter (Fig. 3). Northeast–southwest-trending high-angle normal faults are dominant around the epicenter (Figs. 3, inset c, and 9a–c). The sense of fault slip is supported by stratigraphic offsets

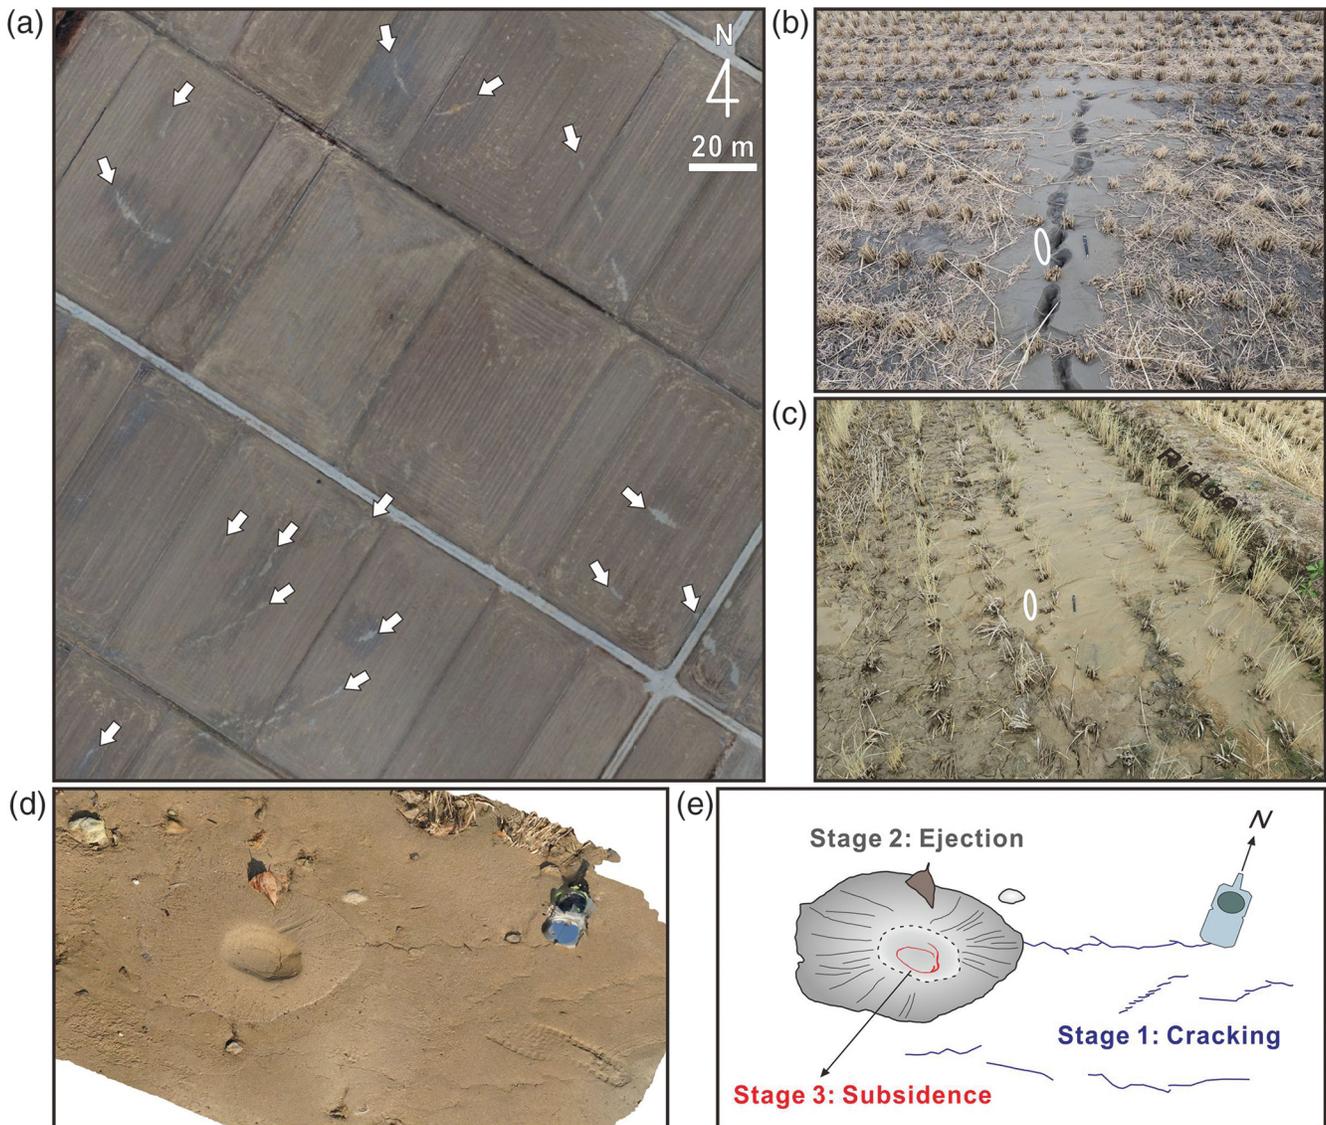
Figure 4. Examples of sand blows associated with the 2017 Pohang earthquake. (a) A conjugate system of sand blows on rice fields identified by unmanned aerial vehicle (UAV)-derived images (ground resolution of ~ 2 cm). (b,c) Field photos showing sand blows erupted through ground cracks or man-made structures (e.g., ridges; adapted from Gihm *et al.*, 2018). Circles indicate pencil for scale. (d,e) A 3D image and sketch of a sand volcano ejected through a ground crack on the beach.

The sand blows exhibit linear patterns on the surface (Fig. 4a–c), and average 5.44 m in length, with several sand blows up to 70 m long (Gihm *et al.*, 2018). Overall, the linear patterns of sand blows are subparallel or subperpendicular to the earthquake rupture (Fig. 3, inset a). This may imply that coseismic ground cracks, often linear features, provide a pathway for ejecting sand. This process seems to be common for other types of sand blows. For example, Figure 4d shows a conical-shaped sand volcano on a beach that formed in response to a sequence of processes (Fig. 4e) including: (1) cracking with a preferred orientation of northeast, (2) ejection of sand at the lateral tip of the crack (see a fallen leaf arrested by sands), and (3) subsidence of the central part.

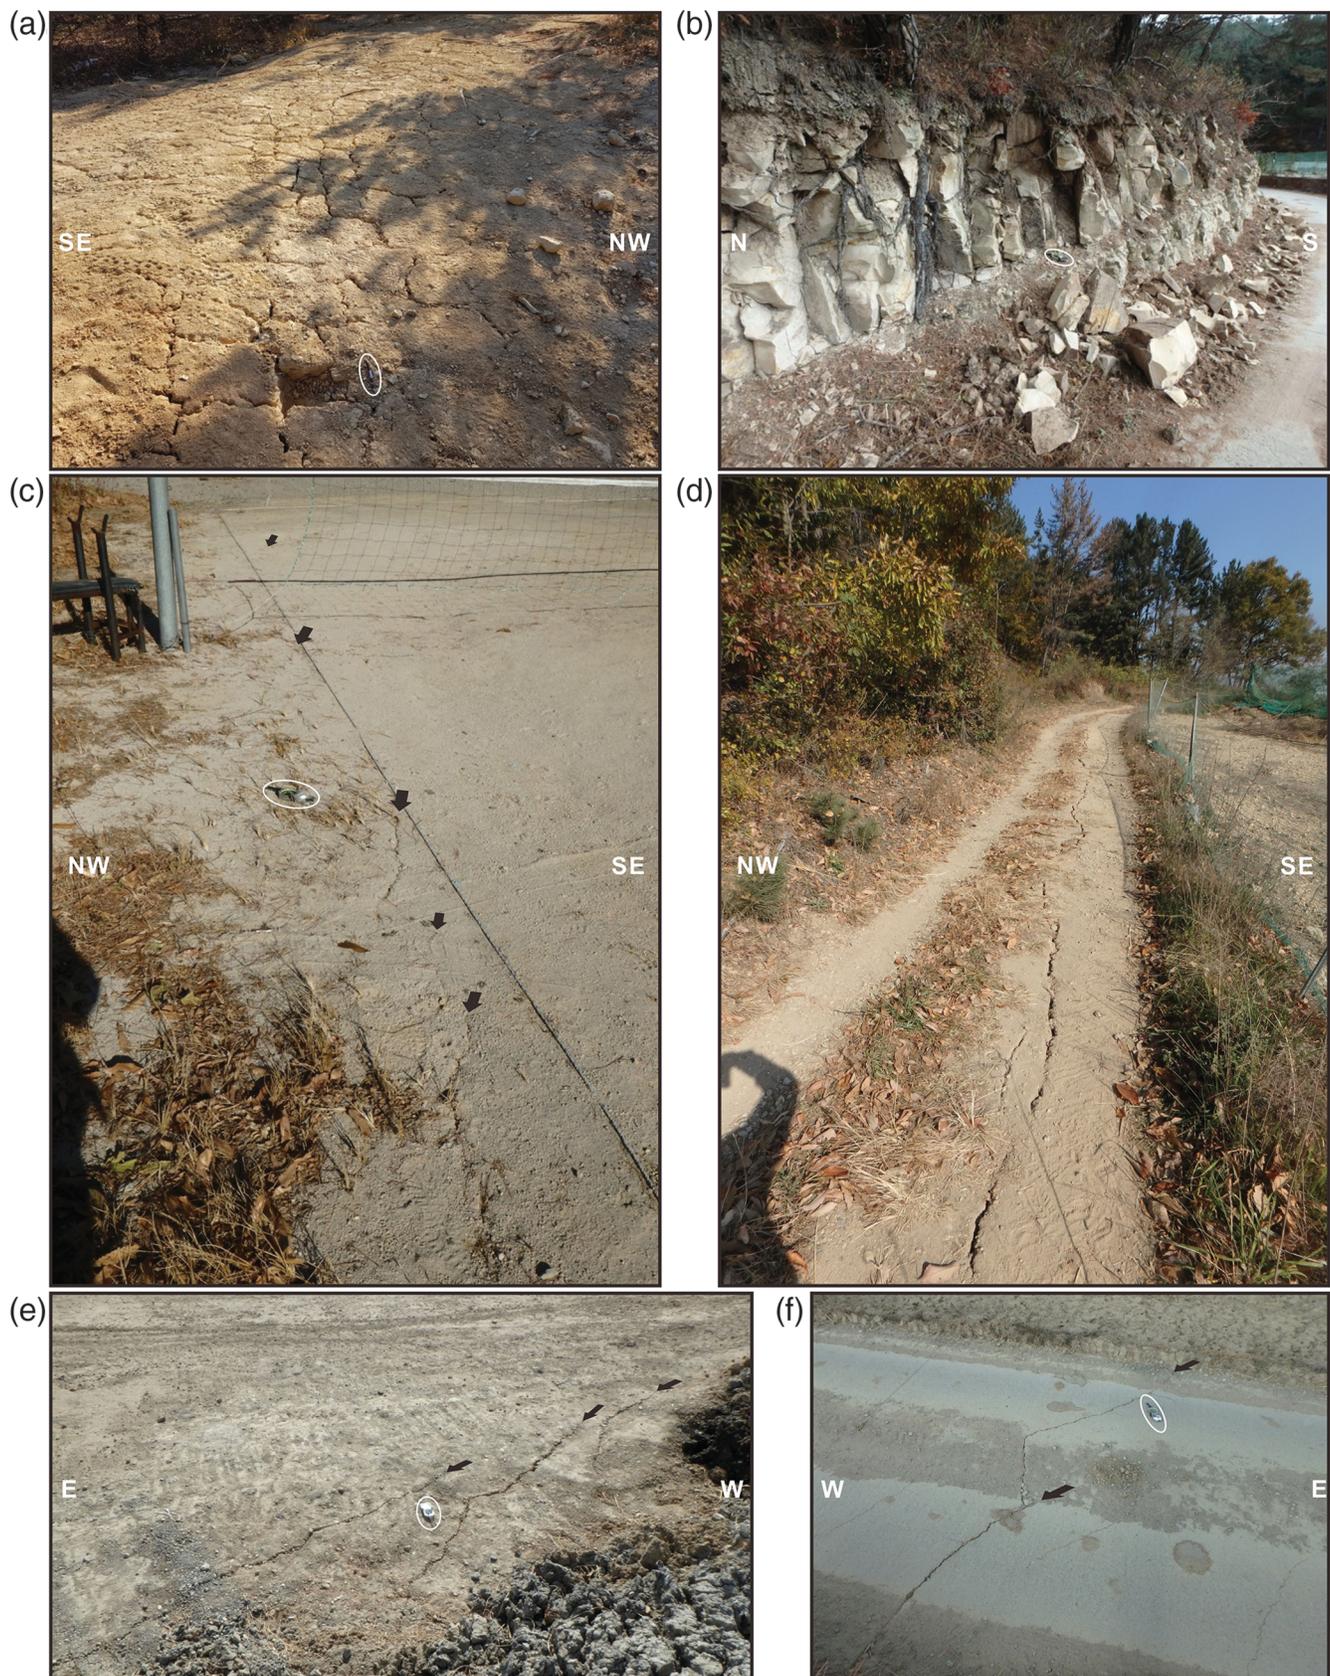
Figure 5. Photographs of ground cracks induced by the 2017 Pohang earthquake (locations of each photograph shown in Fig. 3): (a,b) block jointing in bedrocks and (b) its related rockfalls. En echelon cracks on the dirt of (c) on a playground, (d,e) along a road, and (f) across a paved road. Trends of the each en echelon cracking zone are subparallel to the orientation of the main rupture. Circles indicate compass for scale.

In the mountainous areas east of the epicenter, conjugate extensional fractures were observed in Tertiary sedimentary rocks (Fig. 5a). At some sites, surficial cracking caused small-scale rockfalls on road-cut sections during the earthquake (Fig. 5b). En echelon arrays of ground cracks were observed on unconsolidated ground (Fig. 5c–e). The orientations of en echelon cracking zones are typically northeast–southwest (Fig. 3, inset b), subparallel to the earthquake rupture. Some of the en echelon cracks show a left-stepping geometry consistent with a component of right-lateral shear, which is the same with the sense of strike-slip component associated with the Pohang earthquake (Fig. 5c). Some of them, however, exhibit a right-stepping geometry indicating an opposite strike-slip sense to the main rupture (Fig. 5e,f).

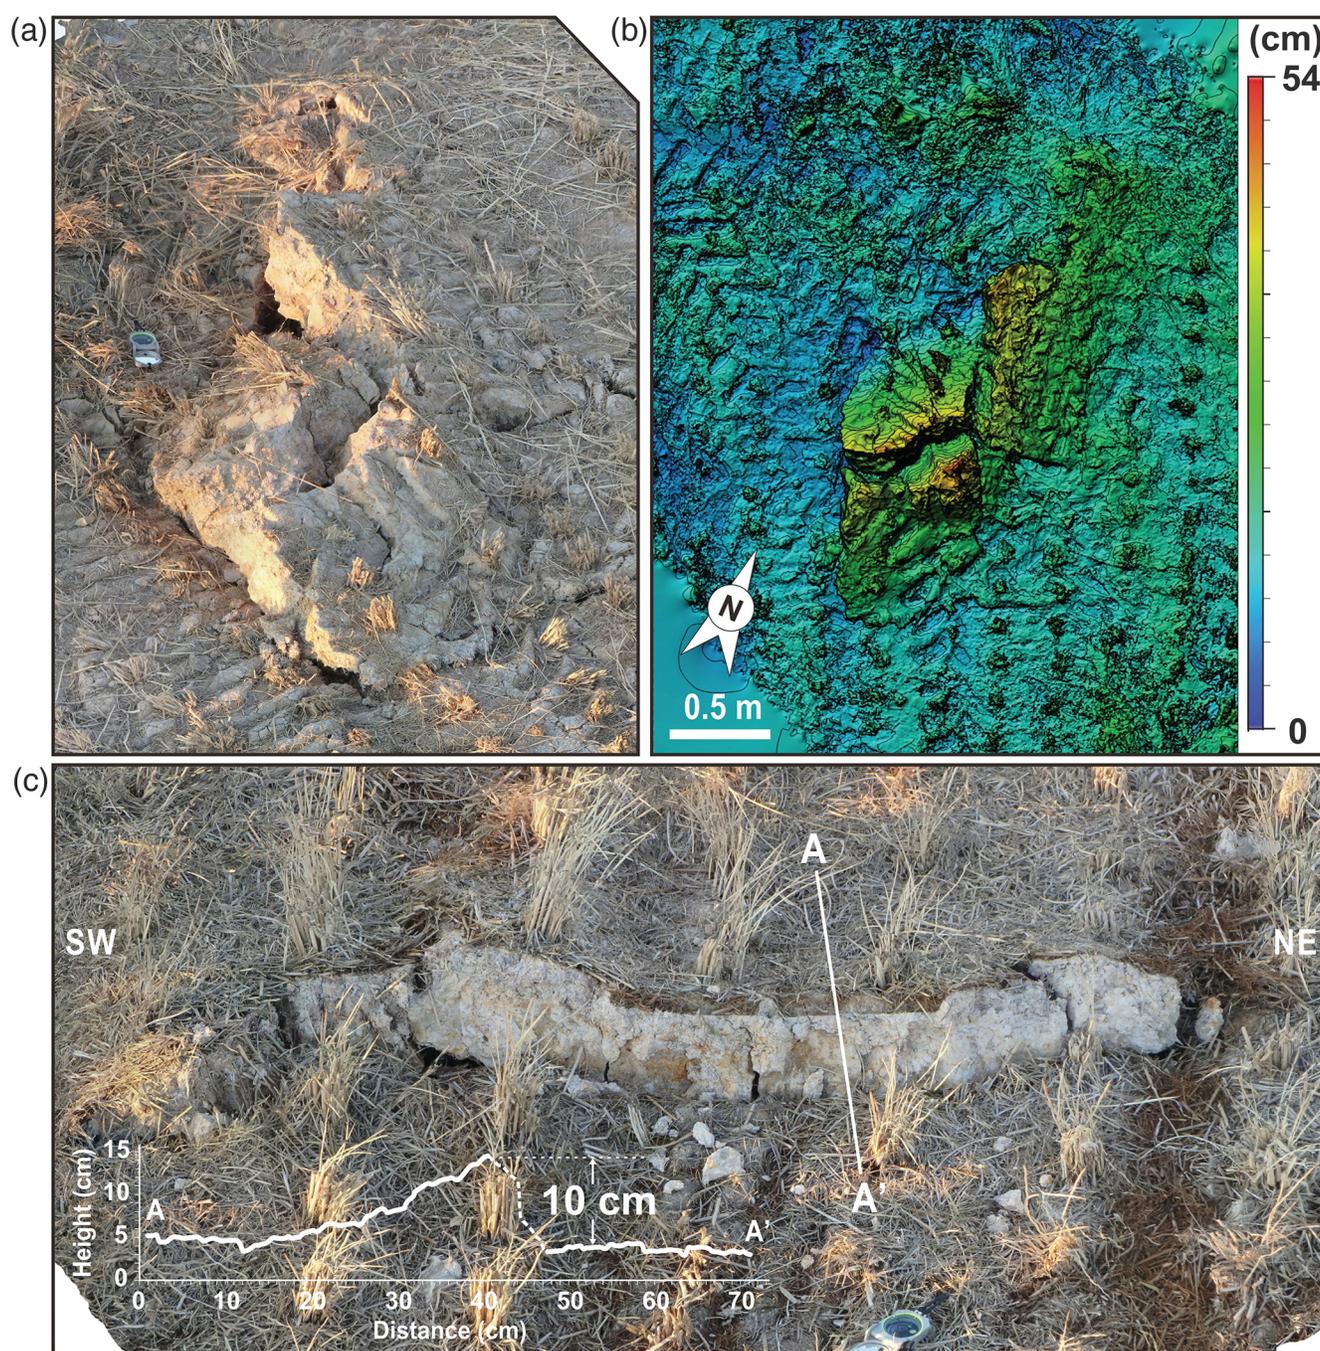
Figure 6. 3D images of rice paddies deformed by the 2017 Pohang earthquake. (a) A structural pattern similar to mole tracks indicating a potential lateral component of motion during uplift. (b) A digital elevation model produced by Photoscan displaying about a half-meter of uplift across a pop-up structure. (c) A vertical profile across a mole track showing about 10 cm of vertical deformation.

At a few sites northwest of the epicenter, ground deformation was observed on rice fields. One example is a linear mound-like feature caused by cracking and lifting up of a dry topsoil layer of the rice paddy (Fig. 6a). Although individual cracks of the deformation feature trend subparallel or orthogonal to furrows on the rice paddy, the overall orientation of the feature is subparallel to the Pohang earthquake rupture. A digital elevation model (DEM), generated with the Agisoft Photoscan program, indicates about 0.5 m of vertical deformation (Fig. 6b). These features are similar in appearance and morphology to mole tracks caused by surface ruptures but are not long or continuous. Another example shows about 10 cm of vertical deformation along a single vertical crack, and the amount of deformation is similar to the thickness of a dry topsoil layer (Fig. 6c). The orientation is subparallel to both furrows on the rice paddy and the Pohang earthquake rupture. In the field, we confirm that small empty cavities formed just below the deformed topsoil layer. Based on the InSAR analysis, there was almost no surface displacement around the sites of these vertical soil deformations (Figs. 2a and 3). We infer that the local pop-up-like deformation of the soil is the result of horizontal ground shaking of rigid soil blocks, and not primary tectonic deformation (i.e., not surface rupture). This is supported by locations and orientations of the deformational features, which are

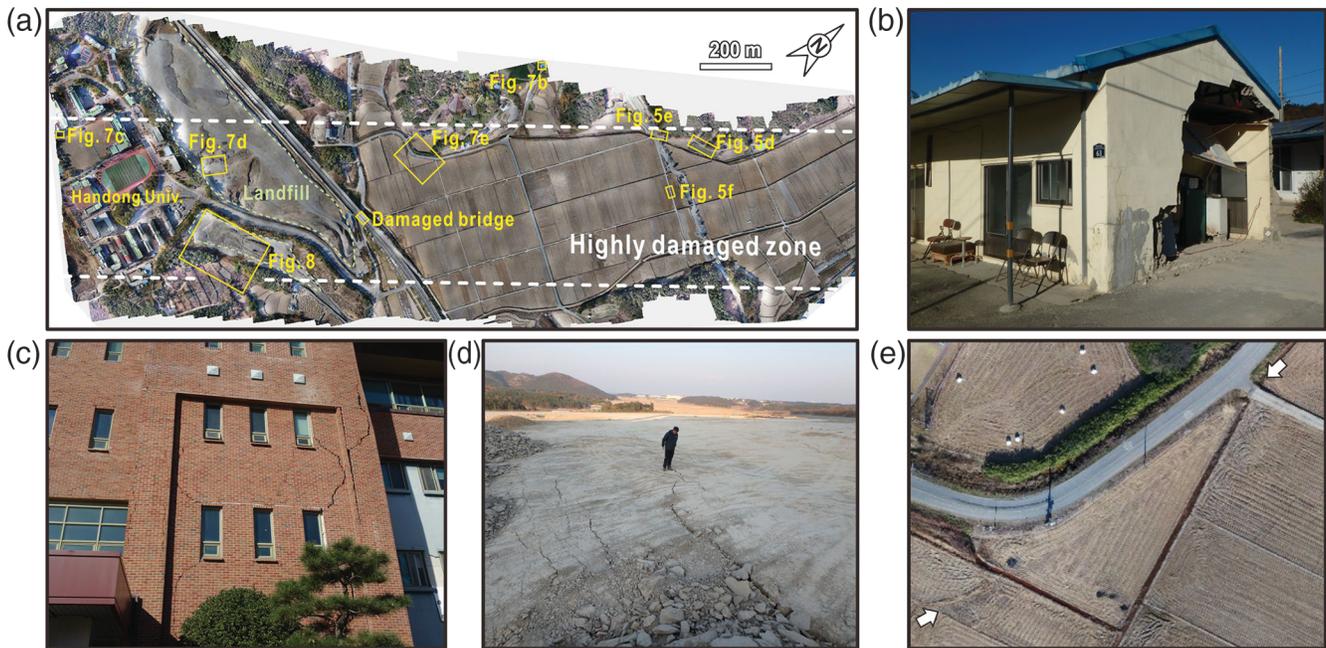
Figure 7. (a) A location map imaged by UAV-derived photos showing (b,c) field examples of structural damage and (d,e) surficial cracking associated with the 2017 Pohang earthquake. These features are along the projection of the blind earthquake rupture (see details in the [Discussion](#) section).

A series of ground cracks were observed within an about 400-m-wide zone centered around Handong University, one of the areas most damaged by the Pohang earthquake (Fig. 7a). A number of buildings on the University campus and in neighboring villages suffered from significant damage (Fig. 7b,e); a bridge was partially closed due to damaged piers (Fig. 7a). Within this zone, ground cracks were recognized on rice fields, unpaved and cemented roads, and construction sites (Figs. 5d–f and 7d,e). Most of these cracks show a preferred northeast–southwest orientation.

Numerous cracks were widely distributed on landfill sites, which are located within the highly damaged zone (Fig. 7). Some cracks are characterized by dimensions of tens of meters in length and a few centimeters in vertical separation. Figure 8 shows an example of ground deformation on and around a landfill site. Digital orthophotos and DEM data were produced by UAV-derived images, and informed detailed mapping of the ground cracks. At the southeastern side of the landfill, a rice paddy exhibited an uneven and folded relief, characterized by curvy and anastomosing crack patterns (Fig. 8b). Extensional cracks were observed north of the deformed ground. Many cracks were formed on the landfill cap, which is about 20 m higher than an undeformed rice paddy (a datum surface in Fig. 8b) (Fig. 8c,d). The cracks show a fan-shaped distribution in map view (Fig. 8c), even though they are predominantly oriented to the northeast–southwest. Vertical separation along the cracks indicates that the southeastern side moved down relative to the northwestern side (Fig. 8d). The vertical deformation is shown in Figure 8e. In particular, topographical profiles indicate that the northwestern side of the rice paddy, which was originally a horizontal surface, was warped upward more than 1 m (Fig. 8e). The lateral extent of the folded and tilted ground was confined to the rice paddy adjacent to the landfill. Thus, the ground deformation on the rice paddy appears to be a local effect of landsliding generated by strong ground shaking. We infer that the observed ground deformation both on the landfill cap (extension) and on the rice paddy (compression) resulted from a local landfill sliding, and not primary tectonic deformation during the earthquake.

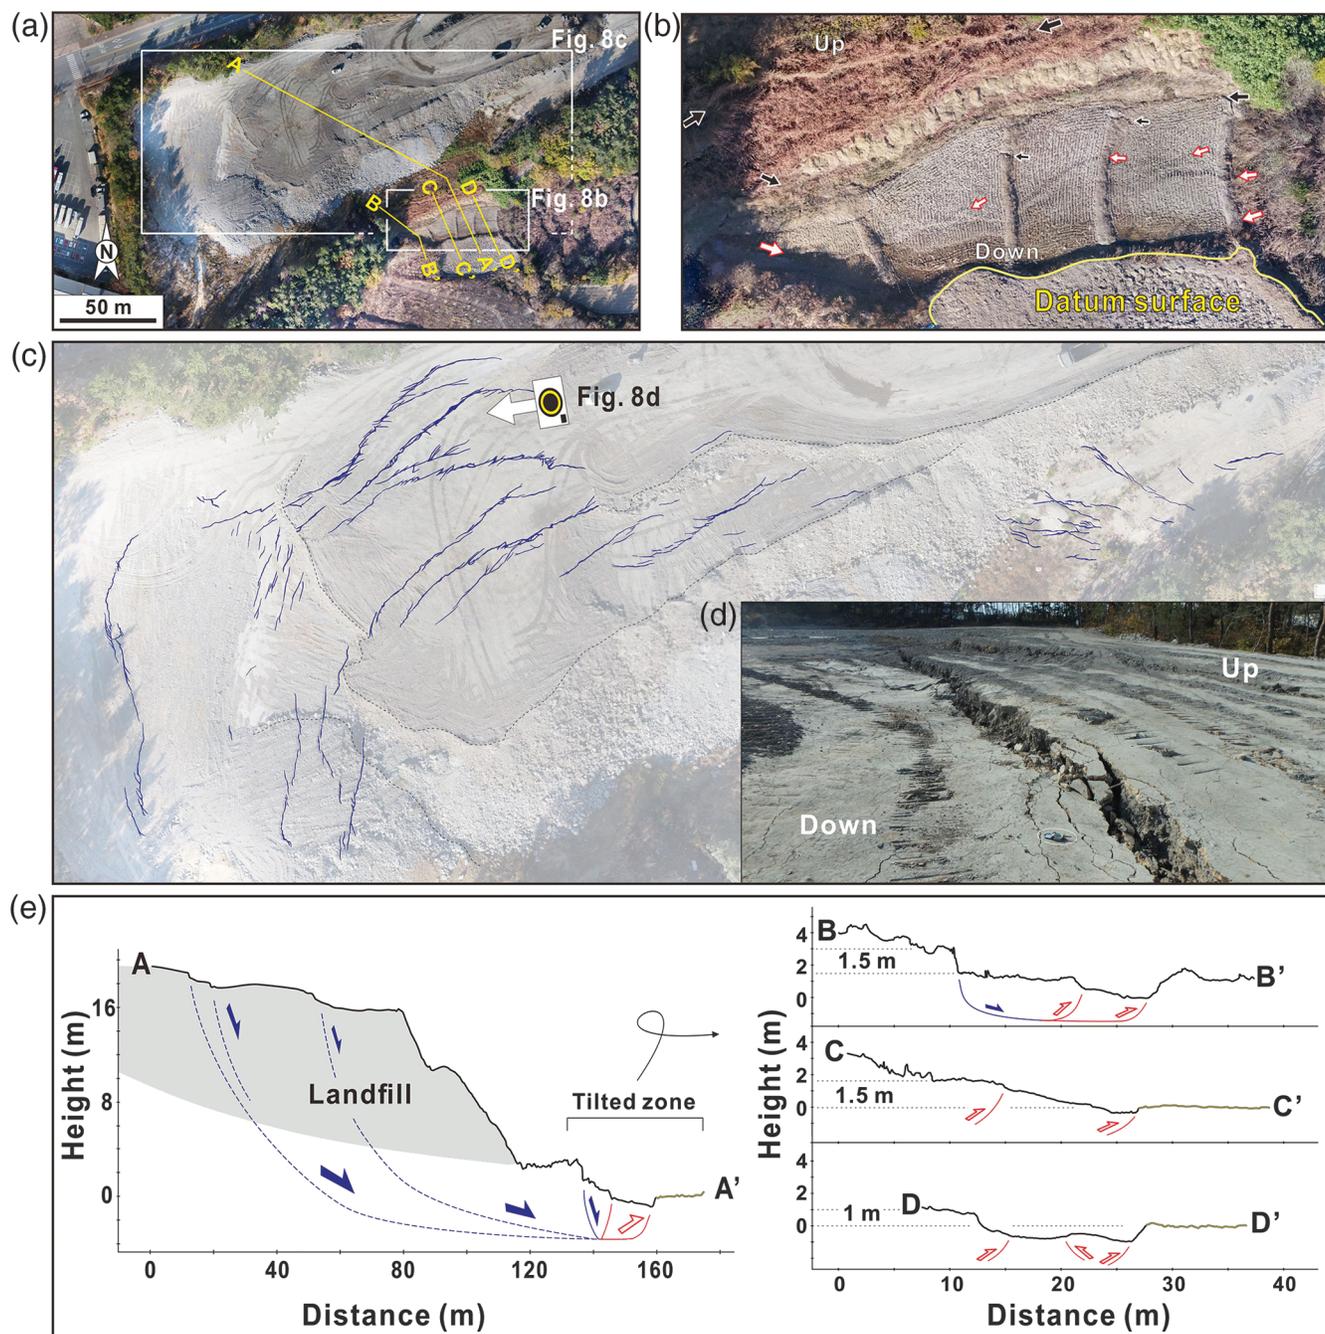
Figure 8. (a) An example of landfill failure induced by the 2017 Pohang earthquake, imaged by UAV-derived photography. (b) Compressional features (unfilled white arrows) such as folded ground on a tilted rice paddy and extensional cracks (filled black arrows) in the northwestern side. These features formed on the ground next to, not on the surface of, a landfill. (c) Arc-shaped cracks on the landfill surface indicating downslope movement of unconsolidated landfill material and possibly mass wasting associated with ground shaking. (d) A photography showing cracks and their related vertical deformation in a detail view. (e) Vertical profiles (A–D) across the landfill slide.

and are associated with a landslide in a landfill (Fig. 8). The location of this highly deformed zone corresponds with a boundary between areas showing two different patterns of both horizontal and vertical surface displacements along the surface projection of the blind rupture (Fig. 11b). This suggests that distributed deformation related to the propagating rupture tip at shallow depth may influence the distribution of ground cracking (Fig. 10). Thus, the mapping results demonstrate that earthquake-induced ground failures may be influenced by both ground shaking (dynamic strain) and processes of blind faulting (static strain), involving reverse slip and related surface folding (Philip and Meghraoui, 1983).

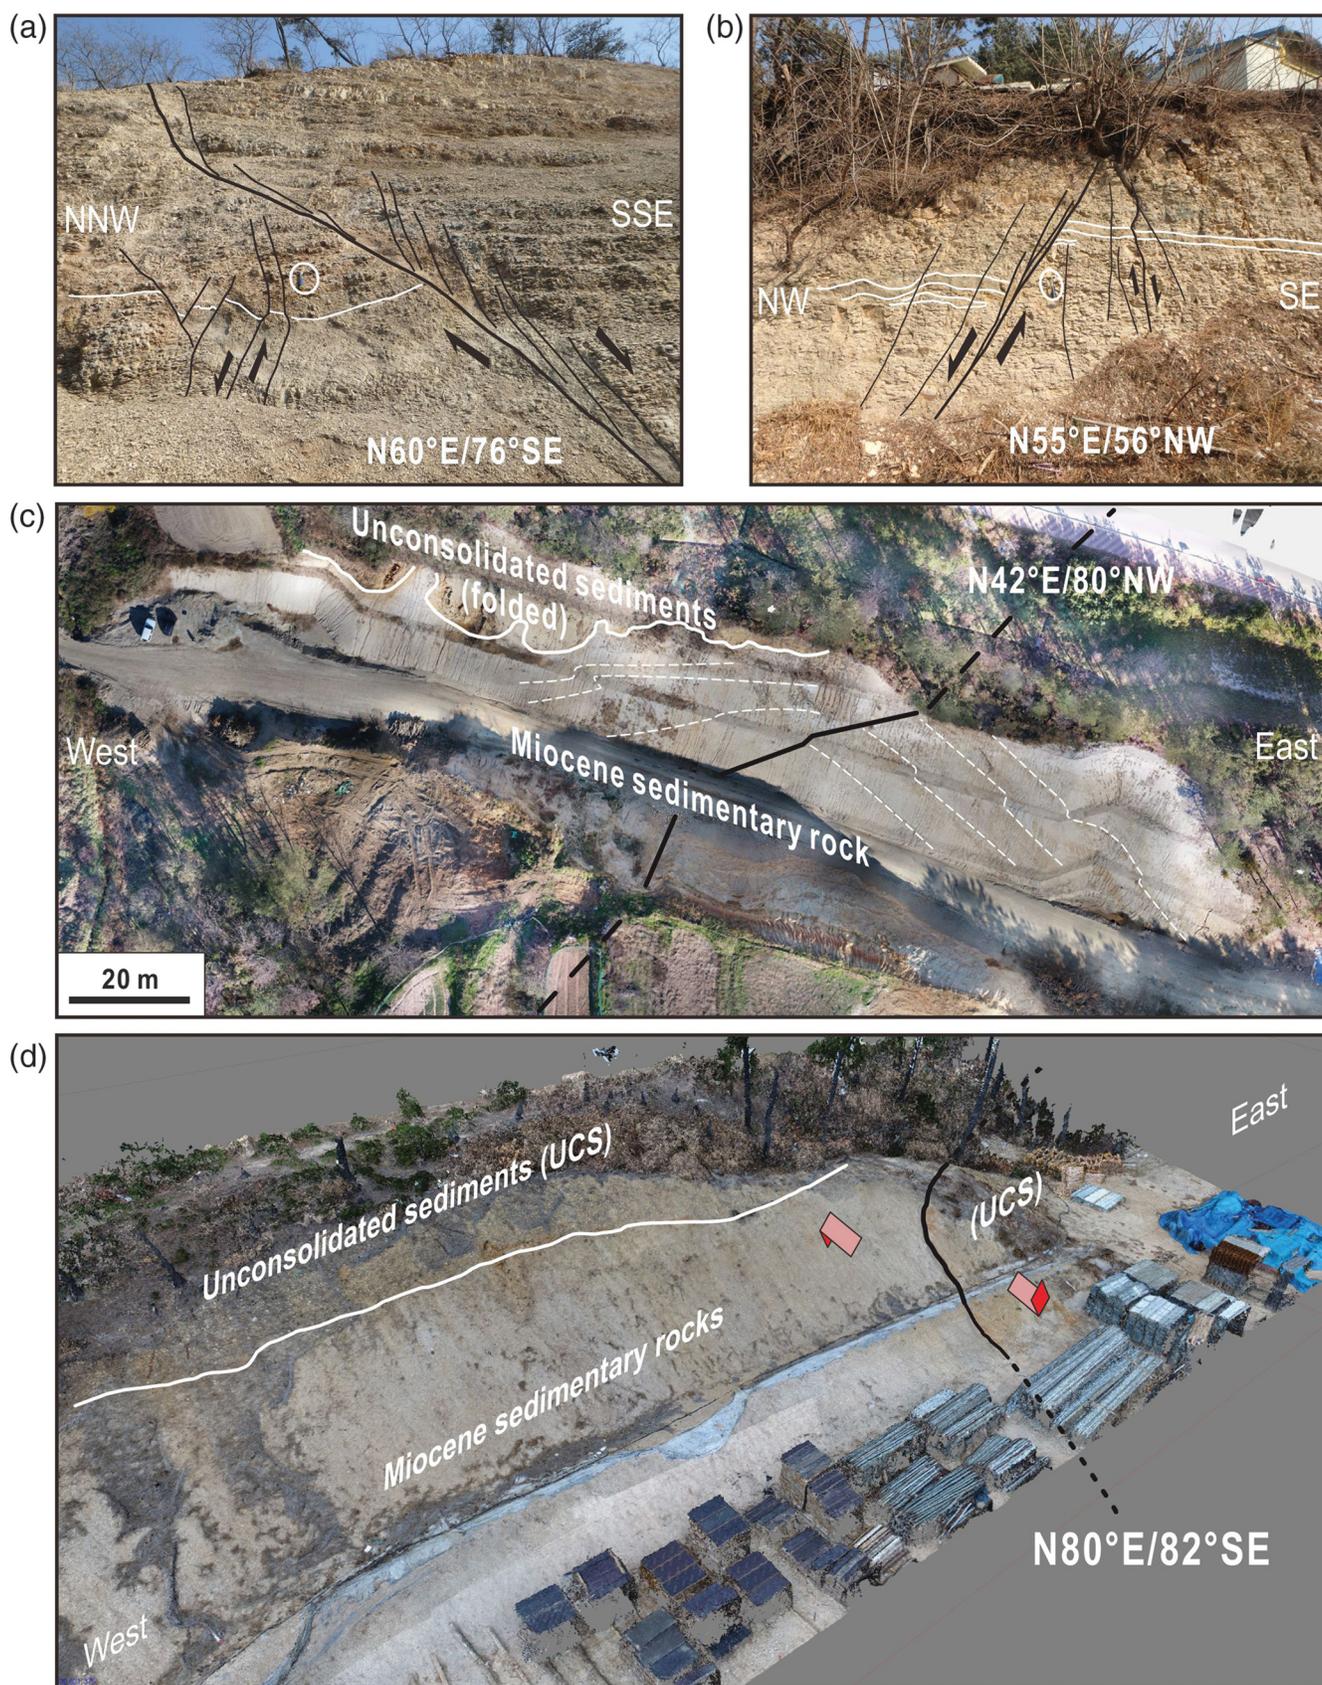
Figure 9. Photographs and simple sketches for fault outcrops in the vicinity of the epicenter of the 2017 Pohang earthquake. (a,b) Field photos showing a conjugate geometry of northeast-trending normal faults. Circles indicate geologic hammer for scale. (c,d) Road-cut sections, imaged by UAV-derived photos, showing unconsolidated sediments cut by faults that indicate the occurrence of previous paleoearthquakes.

and subvertical extensional fractures in outcrop. At each outcrop, the main fault commonly dips to the southeast except in a few cases. The majority of the faults are associated with secondary faults having parallel strikes but opposite dips, that is, antithetic faults (Fig. 9a,b). Around one of these faults, we observed redeposited mudstone as well as highly tilted and/or folded unconsolidated beach sediments implying Quaternary reactivation of the fault (Fig. 9c). The young sediments were also cut by a nearly east–west-trending normal fault, which is consistent with the present-day tectonic stress field (Fig. 9d).

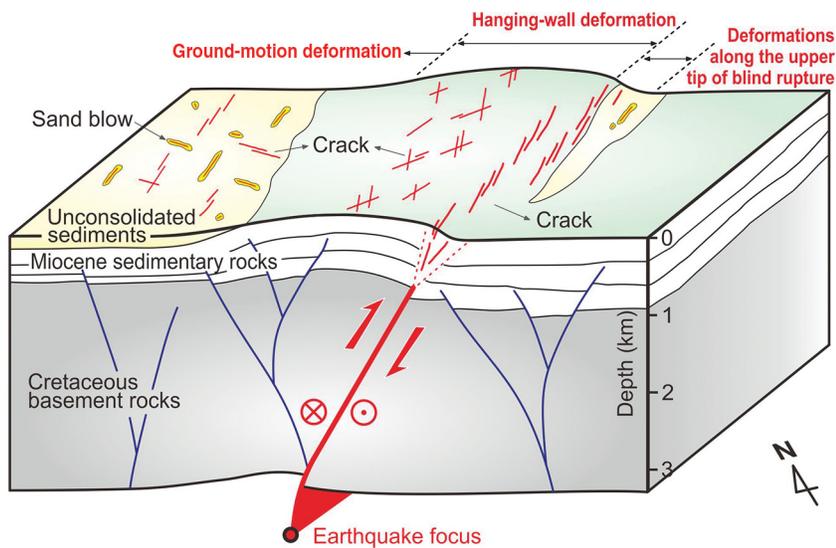
Figure 10. A schematic diagram showing the distribution of surface deformation across the 2017 Pohang earthquake rupture and proposed mechanism associated with blind oblique-slip including reverse-slip component and their related surface folding.

appears to be composed of discontinuous fault segments separated by stepping (or relay) geometry. This is in contrast to other more continuous major strike-slip fault systems in the surrounding areas, that is, the YUFS. We infer that the fault steps may have acted to terminate the propagating coseismic main rupture of the Pohang earthquake. Fault steps represent structural discontinuities that can provide barriers to rupture propagation (Wesnousky, 2006). Additionally, the minimum depth of aftershocks recorded by temporary seismic network is less than 1 km, similar to the thickness of the Miocene mudstone. This suggests that stratigraphic discontinuities and/or vertical variations in structural geometries may contribute toward limiting the up-dip propagation of the rupture (Fig. 10).

in these areas, there was almost no vertical deformation of the ground (Fig. 2a). Figure 11a shows the horizontal component of the peak ground acceleration produced by the Pohang earthquake, and indicates that lateral strong motion near the epicenter was more than 400 cm/s^2 . We attribute the ground cracks on the rice fields to seismic shaking of unconsolidated sediments, particularly horizontal ground motions produced by S waves and surface waves (Fig. 10).

In the foothills east of the epicenter, conjugate pairs of vertical cracks were the typical geometry of ground failures. This area corresponds with the uplifted hanging-wall block of the main rupture. The maximum vertical displacement ranges from 4 to 6 cm according to the InSAR analysis (Fig. 2a) and the surface displacement field constrained by a linear slip inversion of the InSAR data (Fig. 11b; Song and Lee, 2018). Thus, the cracks within the uplifted hills appear to be related to brittle extension along the crest of the folded surface (Fig. 10).

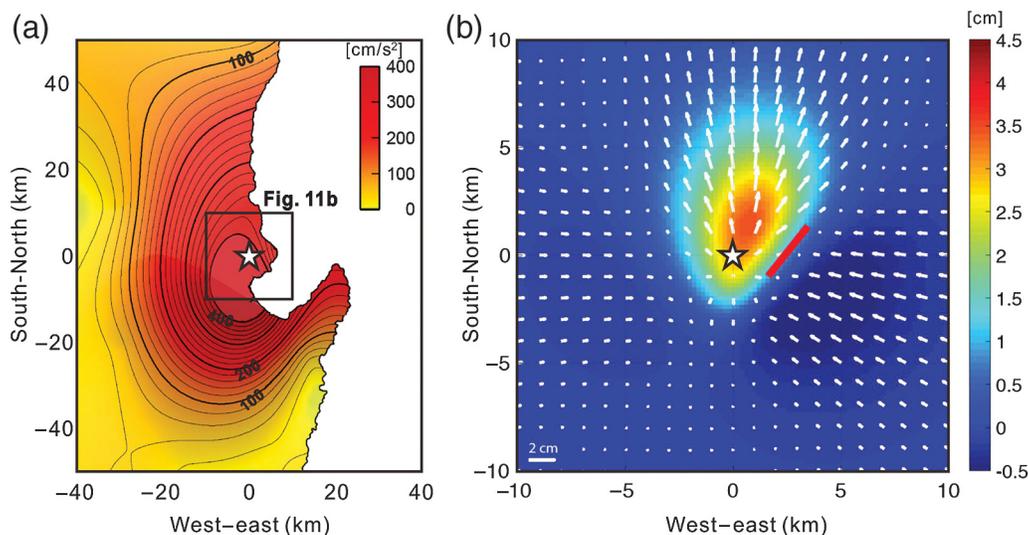
Figure 11. Distribution maps of (a) horizontal component of the peak ground acceleration and (b) both horizontal (arrows) and vertical components (color contour) of predicted ground displacement (adapted from Song and Lee, 2018) associated with the 2017 Pohang earthquake. Stars indicate the epicenter. A red line in (b) indicates the projection of the blind rupture, and this area corresponds with the location of the highly damaged zone shown in Figure 7a.
